Flash floods and related erosion processes at the Gradaščica River catchment

Simon RUSJAN, Nejc BEZAK, Mitja BRILLY, Klaudija SAPAČ,
Matej SEČNIK, Andrej VIDMAR, Matjaž MIKOŠ

University of Ljubljana, Faculty of Civil and Geodetic
Engineering (Slovenia) - FGG

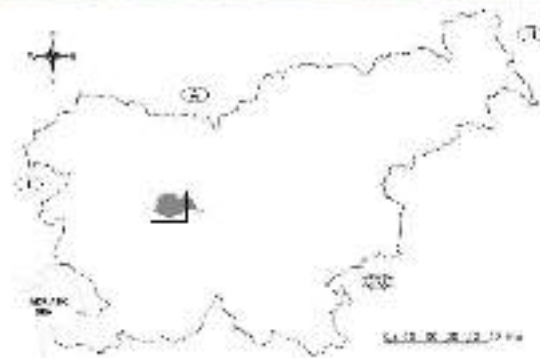
Location

- Meteo station
- Rain gauge
- Disdrometer
- Water level gauge
- ▼ Turbidity sensor

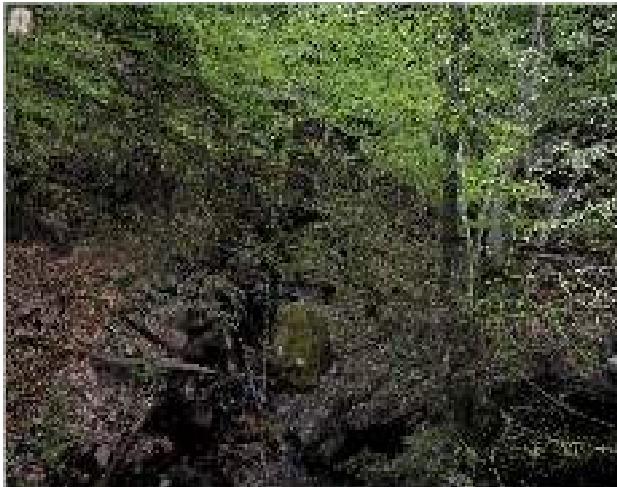
Point cloud

- Based on the points clouds (several million points) the DTMs for years 2013, 2014 and 2015 with 0.05 m grid cell were determined.
- An important step of the DTM pre-processing was removal of large wood.

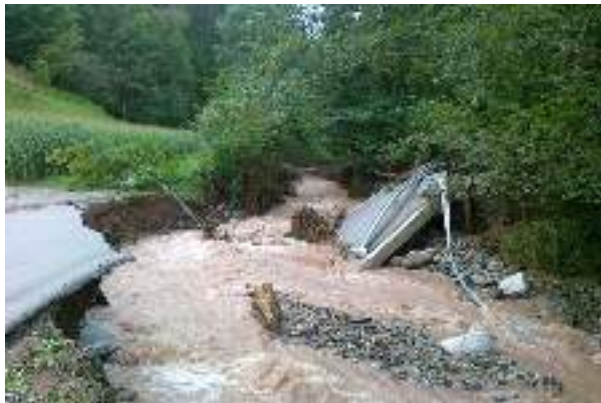
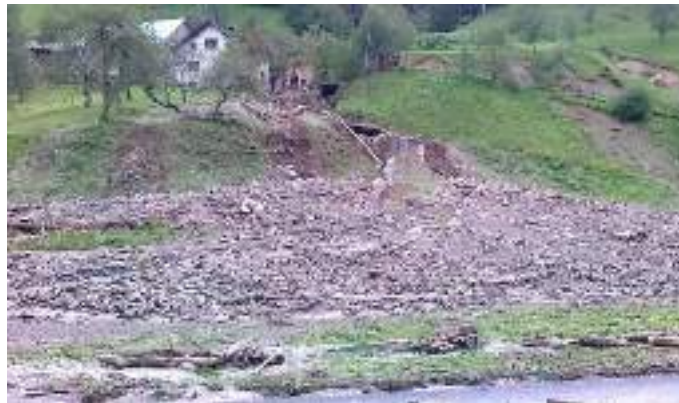
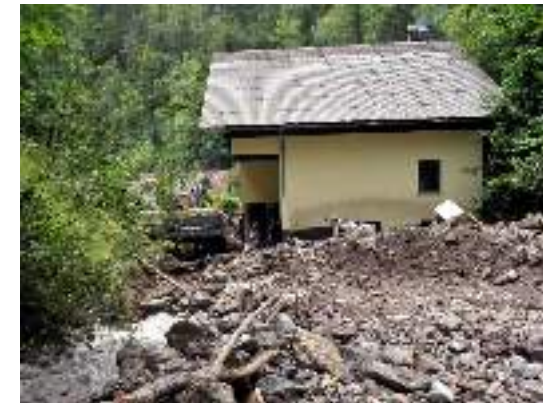
August 2014 extreme event

- Tipping bucket rain gauges measured between 110 and 140 mm in 9 hours, which correspond to the return period between 100 and 250 years. Minute rainfall intensities measured by disdrometer were up to 300 [mm/h].
- More than 50 shallow landslides were triggered.
- About 50 km of roads were damaged, 4 bridges collapsed.
- Flood peak at the Gradaščica River water station: $Q = 69$ [m³/s] (~25-year return period).

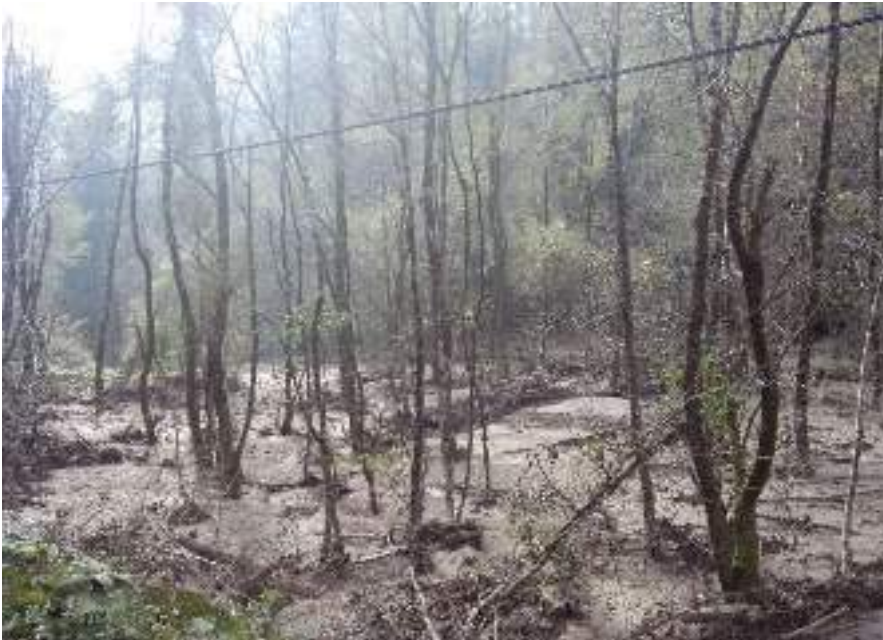
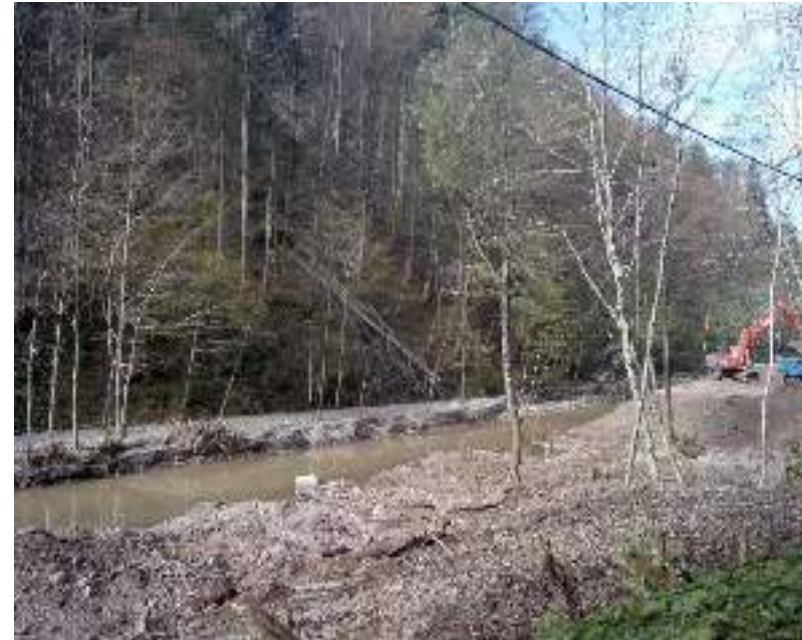
Rainfall event in October 2014

Sediment deposits along the Gradaščica River channel after the October 2014 flood event (left-suspended sediment deposition on the floodplain; right – excavation of the deposited material).

- The recurrence interval of the October floodwave (peak $Q = 72 \text{ m}^3/\text{s} \approx Q_{50}$).
- The total amount of the transported suspended sediment material during the October and November 2014 events was about 21,000 t.
- The specific sediment yield of about 2.6 t/ha.
- The estimated total volume of the suspended material transported along the Gradaščica River channel was approximately 8000 m³.

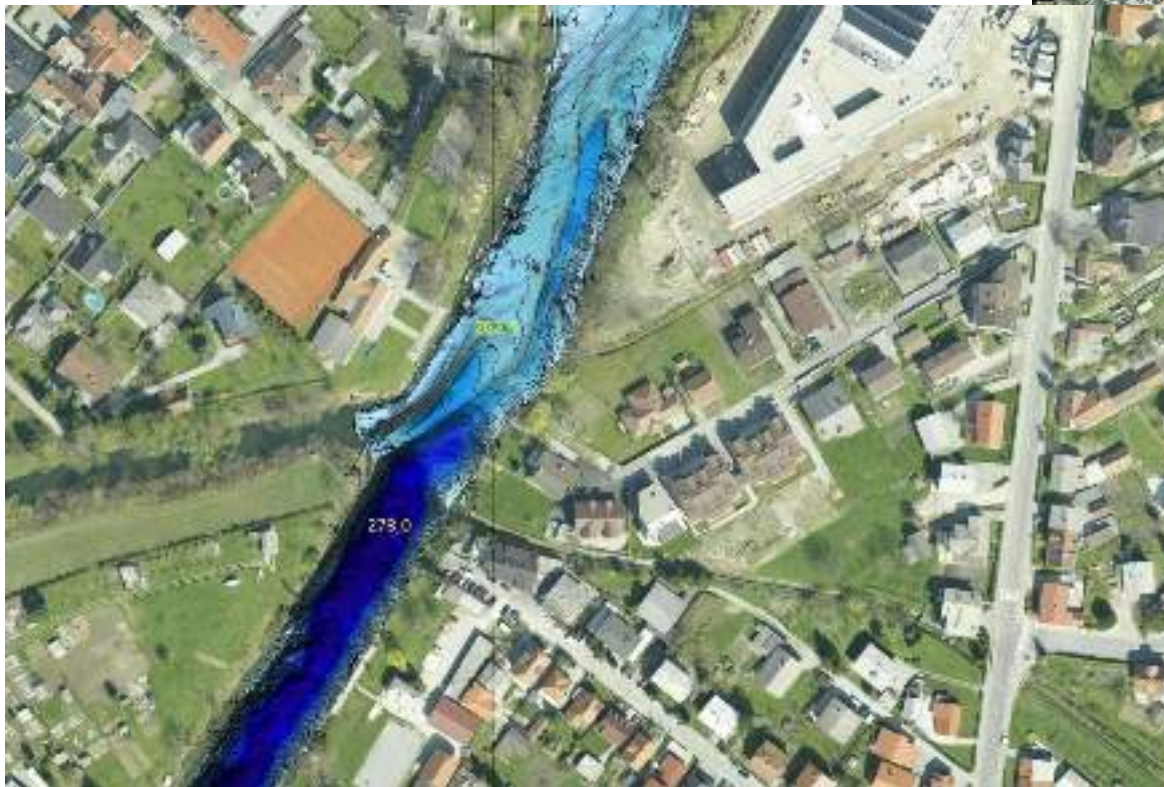
Sediment deposition in Ljubljana river channel

Estimation: 40.000 m³ of deposited sediments.
