Torrential Hazards' Mitigation Measures in a Typical Alpine Catchment in Slovenia

Featured Application: This study presents an overview of the several mitigation measures, including several check dams and flexible net barriers constructed in a typical Alpine torrential catchment in northern Slovenia (Europe) in order to protect infrastructure (i.e., ski resort cabin lift station, access road to the station, downstream settlements) against sediment-related disasters due to torrential hazards, such as flash floods and debris floods, debris flows, and shallow landslides. This newly introduced combination of technical countermeasures in Slovenia withstood the extreme floods in August 2023.

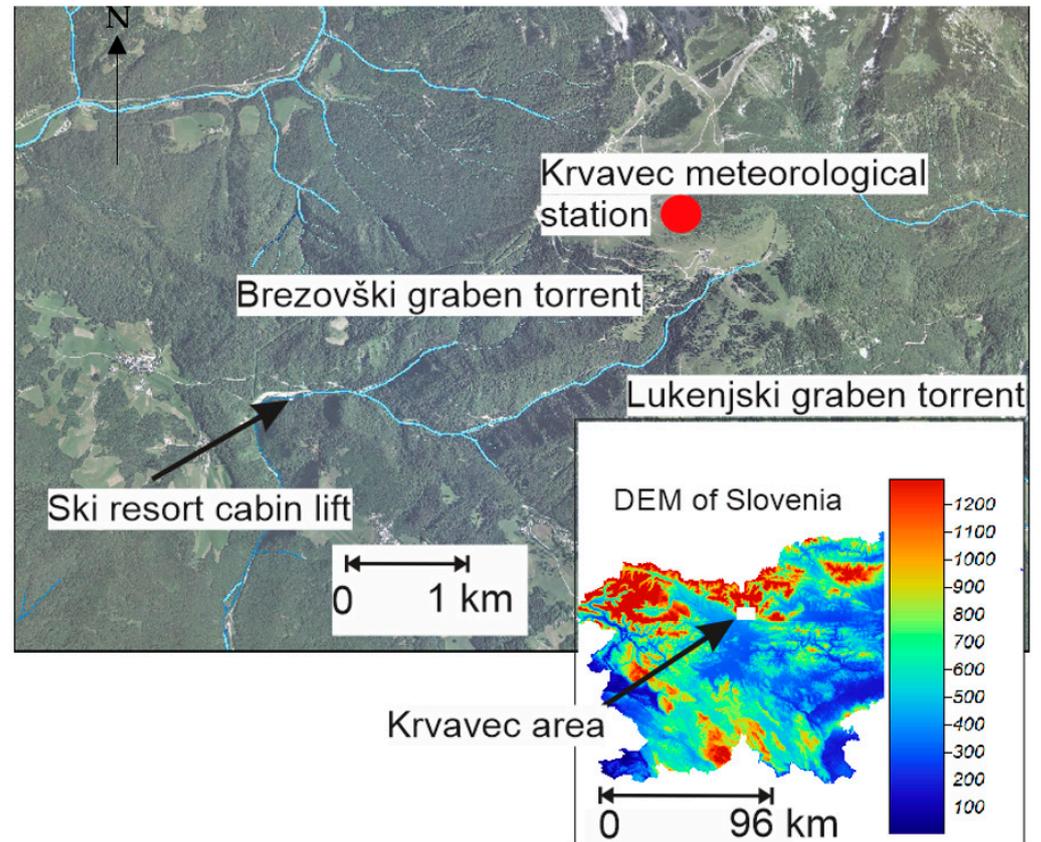
Figure 1. Location of the Krvavec ski resort area on the elevation map of Slovenia (legend is in meters above sea level) and an overview of the situation in the torrents upstream of the valley station of the Krvavec ski resort cabin lift. Slovenia is positioned between 45.50526° to 46.83694° (latitude) and 13.52639° to 16.45091° (longitude). The Krvavec meteorological station is positioned at 14.5333° longitude and 46.2973° latitude and at 1742 m a.s.l.

The Kravac ski resort area is part of the Kamnik-Savinja Alps, a mountain range located in the northern part of Slovenia (Figure 1). The total area of Kamnik-Savinja Alps in Slovenia is around 1000 km², and there are several mountains with elevations above 2000 m a.s.l., with the highest one being Grintovec Mountain with an elevation of 2558 m a.s.l. The Kravac ski resort stretches from around 1500 m a.s.l. to around 2000 m a.s.l. The area is characterized by steep slopes and narrow valleys (Figure 2). The cabin lift is the

main means of transport for skiers in winter during the ski season. As can be seen from Figure 1, there are two steep torrential ravines (i.e., the Brezovški graben and the Lukenjski graben) in the upstream slopes from the station of the cabin car. The average longitudinal channel slope of these two torrents is $\sim 25\text{--}30\%$, and the total catchment area is close to 2 km^2 [22]. Around three-quarters of both catchment areas are forested, while the rest are agricultural areas [22].

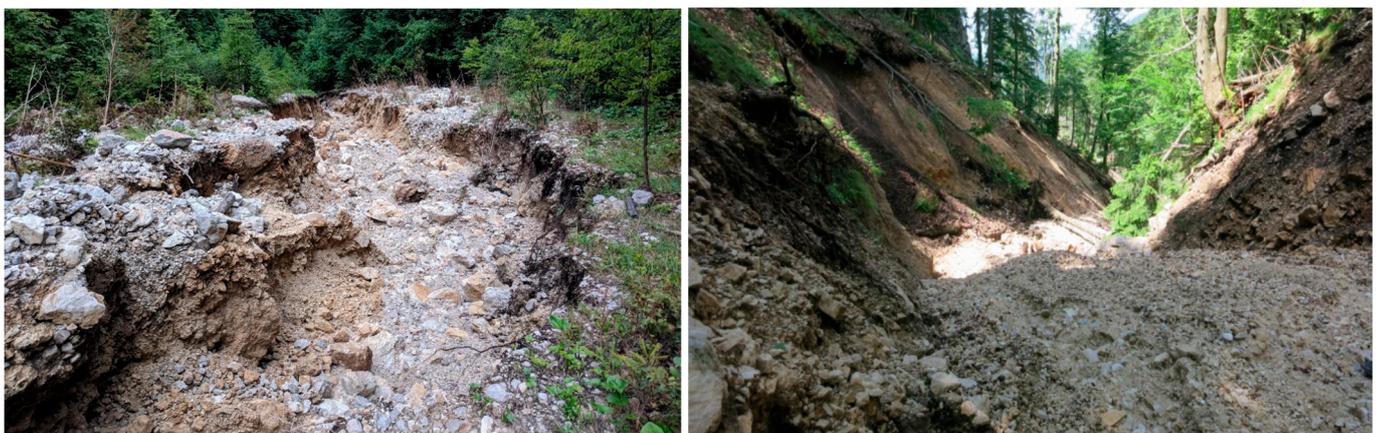
Figure 2. Two photos of the situation in the Brezovški graben and Lukenjski graben torrents, respectively. The channel width is between 1–2 m to several meters.

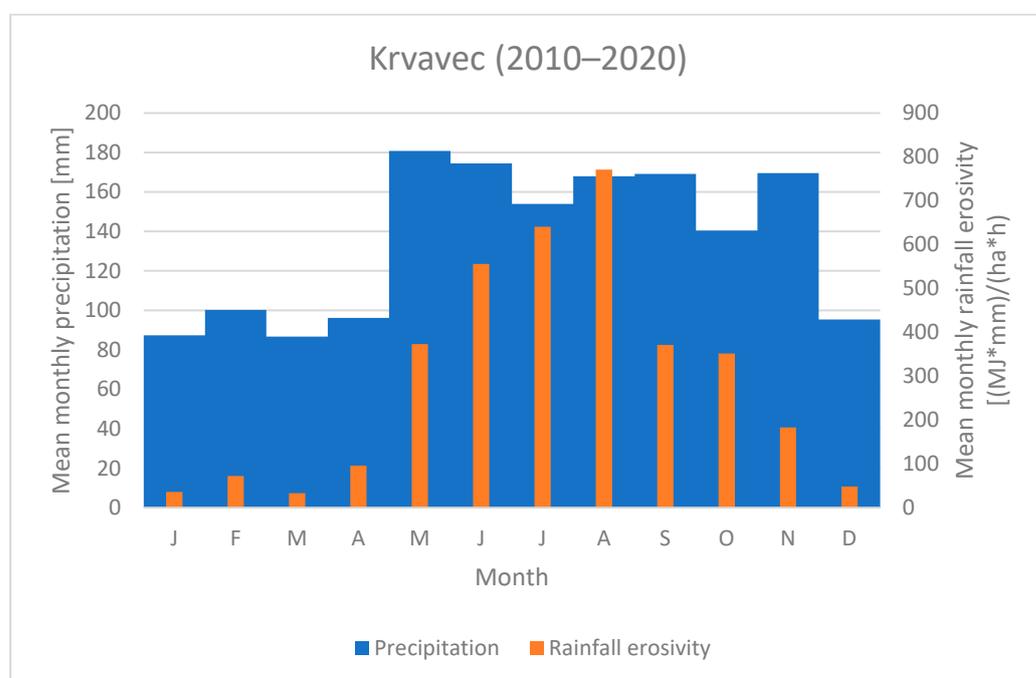
Figure 3. Mean monthly precipitation and rainfall erosivity at the Krvavec meteorological station in the period 2010–2020.

The mean annual precipitation at the top of the Krvavec ski resort area (approx. 1700 m a.s.l.) is around 1620 mm (in the period 2010–2020), with no clear seasonal pattern (Figure 3). Moreover, there is a clearer pattern in the monthly rainfall erosivity distribution with a clear peak in the summer period (Figure 3). The rainfall erosivity was calculated based on the 30-m rainfall data for the 2010–2020 period based on the RUSLE methodology [28] and using the RIST software [29]. The average annual rainfall erosivity in the 2010–2020 period was around $3531 \text{ MJ} \times \text{mm} \times \text{ha}^{-1} \times \text{h}^{-1} \times \text{year}^{-1}$, which can be regarded as relatively large [30]. Therefore, it is evident that hydro-meteorological events can occasionally be relatively extreme in this alpine part of Slovenia. In combination with steep slopes and other torrential characteristics, this can lead to rainfall events, such as the one that occurred in May 2018 (Section 2.2). This local thunderstorm triggered a local debris flood that partially devastated the valley station of the Krvavec ski resort cable car and interrupted the local access road to the station [22]—for protection against such torrential events, several structural protection measures were built in the past [22,23], but most of these torrential structures were already in relatively bad condition before, and especially after the May 2018 event (Section 2.3).

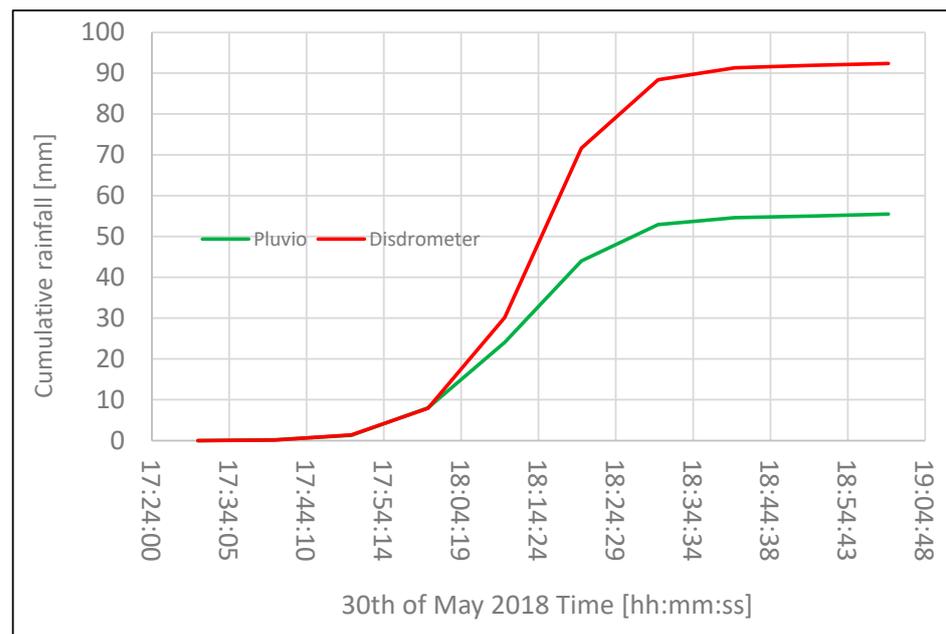
Figure 4. Measured cumulative rainfall using an optical disdrometer and a pluviograph at the Krvavec meteorological station at 1742 m a.s.l. during the extreme event that occurred on 30 May 2018.

On 30 May 2018, a relatively extreme rainfall event occurred in this area [22]. Around 50 mm of rainfall fell in around 30 min, corresponding to the statistically estimated return period of over 50 years. The total event duration was very short (less than 3 h), and the majority of rainfall was concentrated in around 15–30 min (Figure 4). The rainfall erosivity for this specific event based on the 30-m rainfall data can be estimated to be over $1420 \text{ MJ} \times \text{mm} \times \text{ha}^{-1} \times \text{h}^{-1} \times \text{year}^{-1}$, which is almost half of the total annual rainfall erosivity and almost twice as large as the average monthly erosivity at the Krvavec meteorological station (Figure 3). Furthermore, in the 2010–2020 period, this was the event with the second-highest rainfall erosivity. More specifically, the average erosivity per event at the Krvavec meteorological station was around $90 \text{ MJ} \times \text{mm} \times \text{ha}^{-1} \times \text{h}^{-1} \times \text{year}^{-1}$.

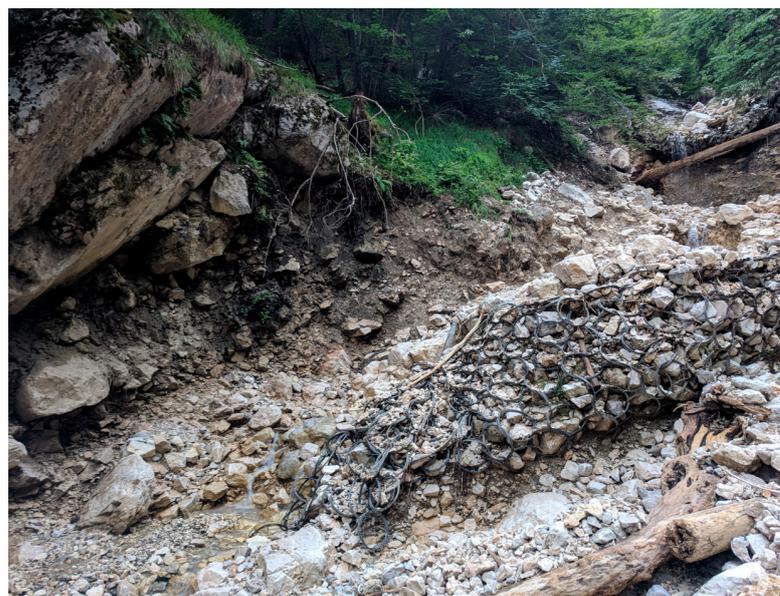
Figure 5. One example of the consequences of the May 2018 event on the existing infrastructure in both torrents: a partially destroyed already filled flexible barrier.

As indicated by Bezak et al. [22], the extreme rainfall in May 2018 triggered the local debris flood and caused intense erosion and sedimentation processes in both Brezovški graben and Lukenjski graben torrents. At the valley station of the Krvavec cable car, around 10,000 m³ of relatively coarse debris was deposited, and it was assumed that the main source of the debris material was the Brezovški graben since the debris material from the Lukenjski graben was deposited upstream (before the confluence of the Brezovški graben and Lukenjski graben torrents) from the valley station of the Krvavec cable car (i.e., in the debris flow fan area) [22]. The debris flood caused extensive damage to the existing torrential infrastructure in both torrents (Figure 5). Hence, in order to protect the valley station of the cable car and the downstream area along the access road to the station, new countermeasures needed to be implemented (Section 3.3).

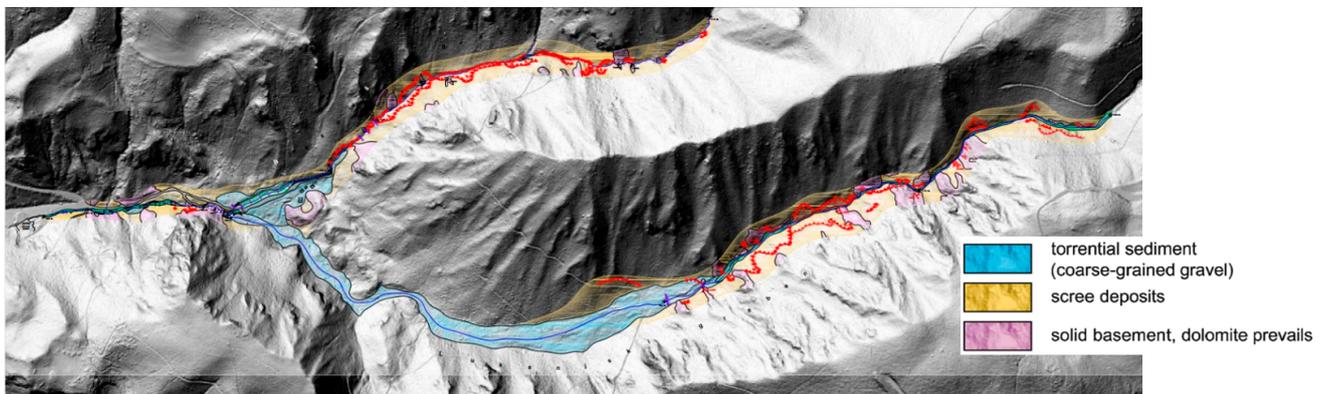
Figure 6. Engineering geological map of the area with the identification of the main sediment sources.

After the May 2018 event, a geological survey was carried out to determine geological conditions for planning and executing new mitigation measures (Figure 6). The main objective of the field survey was to estimate the possibility and magnitude of future mass movement and debris flood events. Areas with deposited debris material and areas with high erosion potential (Figure S1) were identified to secure input data for debris flood modeling and countermeasures design process.

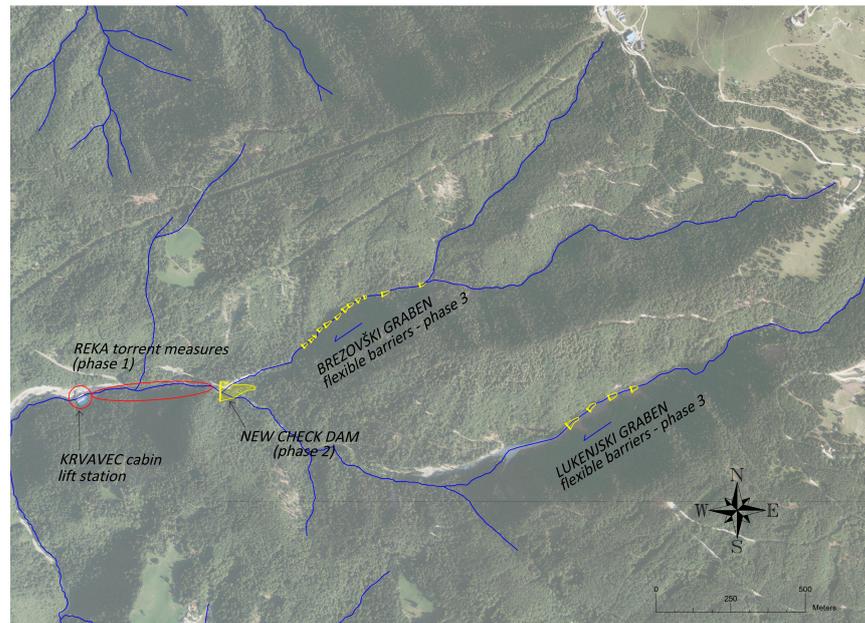
Figure 7. Location of proposed measures and an indication of the three main phases used to mitigate the future risk of torrential hazards.

Mitigation measures were roughly divided into three sections, respectively, phases (Figure 7). The first phase was a restoration of existing concrete structures (channel regulation works) on the Reka torrent, i.e., downstream of the Brezovški and Lukenjski torrents confluence. The second phase was planning and building a large slit check dam just downstream at the confluence of both torrents to temporarily retain future mass flows and slowly dose debris to the downstream section. In this location, there was already a small check dam, but the capacity of the sediment trap was only about 500 m³, which is a relatively small capacity compared to possible future events magnitude (volumes). A new slit check dam is designed with the largest possible sediment capacity in this location of close to 14,000 m³. The third phase includes measures to reduce erosion potential in the Brezovški and Lukenjski graben catchments. Both upstream sections have a large erosion potential, and a large amount of mixed coarse and fine debris material can be mobilized during future rainfall events. Since the area is hardly assessable even on foot, non-conventional countermeasures were sought. As an appropriate structure, a flexible ring-net debris flow barrier was selected, which can be transported to a construction site with helicopters or forestry cableways. No heavy machinery (such as excavators) is needed for installation—as it could not be applied—and light machinery was applied (such as so-called spider excavators). The main objective of the third phase was to reduce in-channel erosion intensity via stabilization of the torrent channels (side-slopes reduction at the same time). Geological information shown in Figure 6 was used for the selection of the optimal locations of the flexible net barriers. All three phases together present a holistic technical solution for this endangered torrential area and will reduce mass-flow-related hazards for downstream areas (cabin lift valley station, access road, Grad village, etc.).

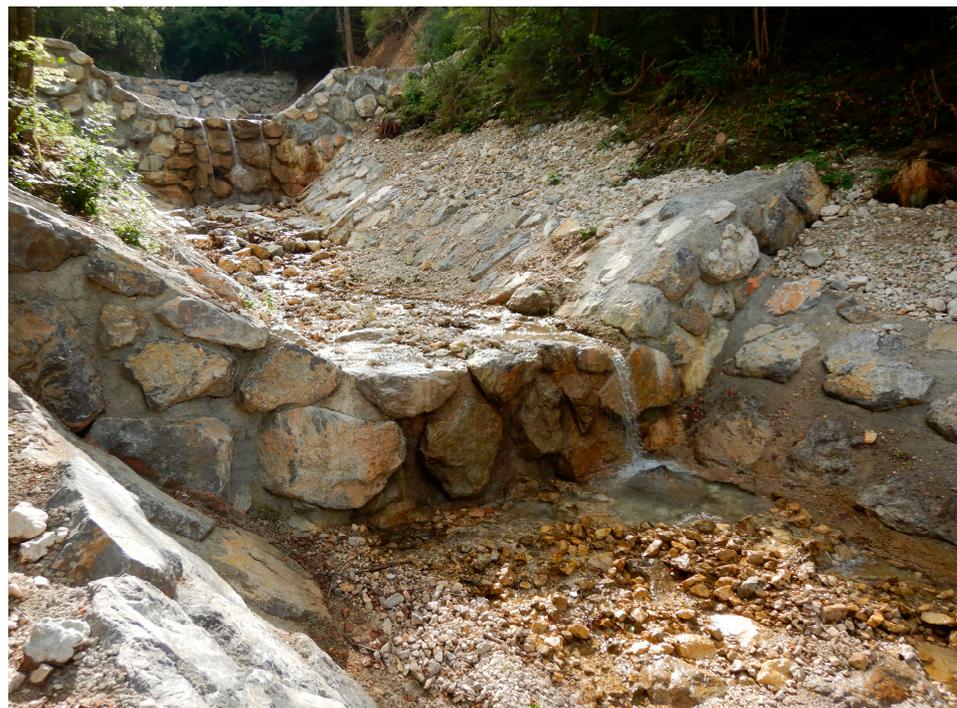
Figure 8. An example of the Reka torrent measures (carried out in 2019, before COVID-19).

The Reka torrent was already regulated in the past (in the last few decades), but mainly concrete and wooden structures were in relatively poor condition, and the May 2018 event severely damaged or destroyed most of them. This section of the Reka torrent is steep, and the structures such as small check dams, low weirs and bank protections are a necessity for channel stabilization. During construction phase 1, executed in 2019 and 2020 (pre-COVID-19), some of the structures were renewed, but most of them were completely reconstructed (Figure 8). Banks with erosion were protected with stone rip-rap structures.

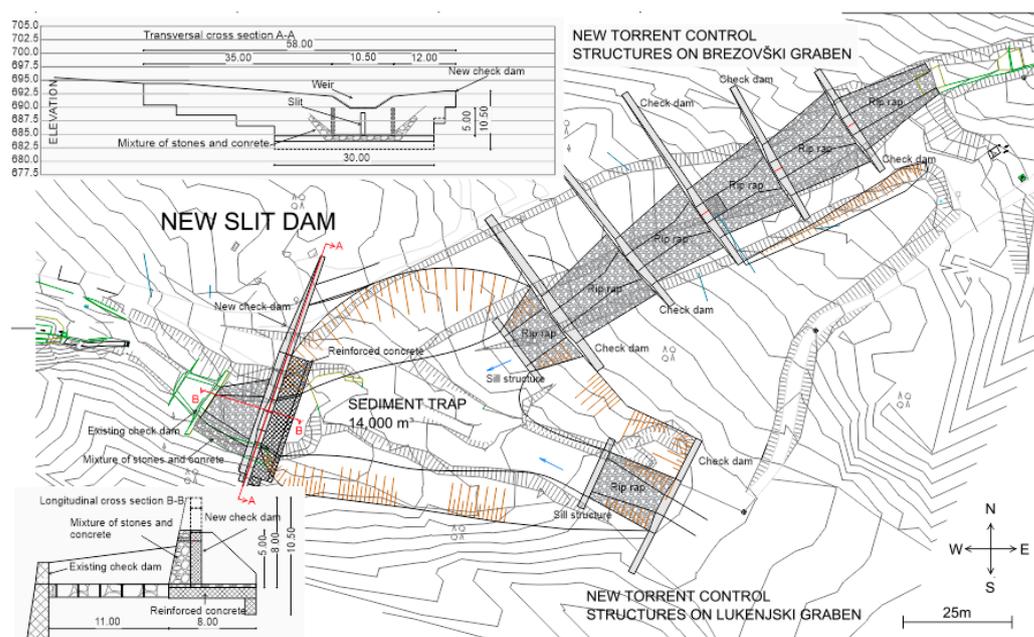
Figure 9. The slit check dam location and its main characteristics, including the transversal and longitudinal cross sections. The spacing among contour lines is 2 m. Additional structures that are to be built are also shown in the figure (e.g., several sill structures).

Due to the high risk of similar or even more severe mass flow events in the future, a large 10.5 m high check dam with approximately 14,000 m³ sediment trap capacity was designed on the confluence of Brezovški and Lukenjski torrent. The check dam was designed as a slit dam to have minimal impact on geomorphological processes in this section and with the aim of ensuring the sediment connectivity and not to completely stop the sediment transport process. Therefore, the sediment transport process will not be completely interrupted, except for extreme events during which large masses of coarse sediments will be mobilized and could present a significant hazard for downstream areas. In the dam design phase, geotechnical research (boreholes, laboratory) was carried out to obtain reliable input data for the dam structural design. Check dam with a construction height of 10.5 m is designed for the dynamic impact of mass flows. It will be built as a reinforced concrete structure, covered with a mixture of concrete and rocks, to ensure a more nature-friendly look.

Together with a new slit check dam, some additional structures will be built to ensure the stability of the upstream section of the confluence (Figure 9). These sections of both torrents will be modified to provide larger sediment trap capacity and erosion stability. The check dam is designed in a location with an access road so that the sediments can be removed regularly, and the whole sediment trap volume is available.

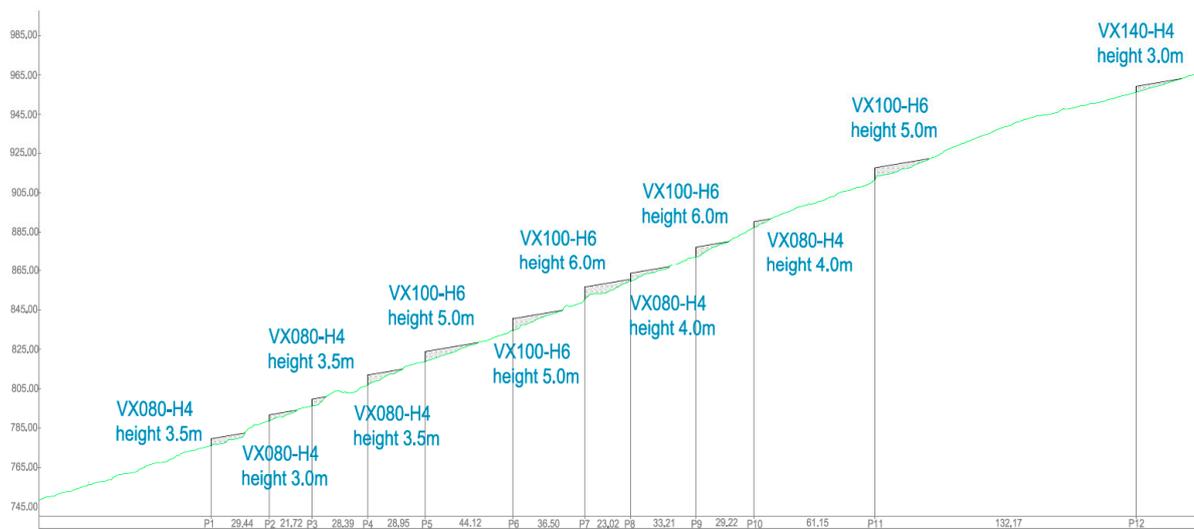
Figure 10. A longitudinal profile of the Brezovški graben with the locations of the 12 flexible net barriers.

A series of 12 flexible barriers were installed in Brezovški graben (12) and 4 in Lukenjski graben (4) to prevent side erosion (bank collapses, slumps) and thus to limit sediment supply from sediment sources (Figure 10). The height of the barriers varies between 2.5 and 6 m, and the sediment trap capacity is between 100 and 800 m³. The top width of the barriers varies between 9 and 25 m. The total retention volume was estimated for 4 barriers in the Lukanjski graben to be over 3000 m³ and for 12 barriers in the Brezovški graben to be close to 5000 m³.

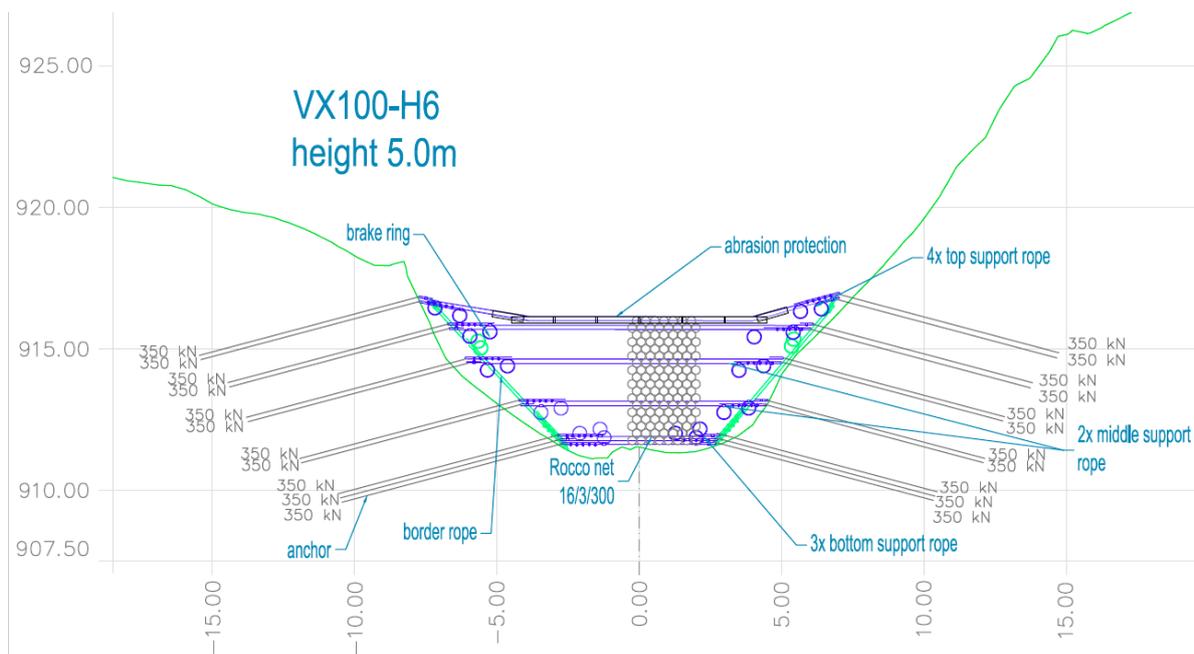
Figure 11. Example of a designed VX barrier.

All the barriers were designed and dimensioned using the DEBFLOW online tool developed by Geobrugg [31]. The design of the barriers was modified because the deposits are not intended to be removed after the events, but the main purpose of the barriers is to reduce channel slope, reduce velocities and support unstable channel banks. Because of this specific design, not all barriers are designed for debris flow impact, but all of them are designed for overflowing forces. The upstream barriers and the barriers with larger distances to the next upstream barriers are designed for debris flow impact, which is one of the possible scenarios in the phase where barriers will be filling up with sediments. The final state of the barriers will be, when all of them are filled up, torrential bed slope reduced and bank erosion mostly mitigated. Based on the topographic characteristics, VX-type (Geobrugg) barriers were selected [31] (Figure 11). Some of them were customized with additional ropes and anchors since there was no need to use stronger, more resistant nets, but only to add some ropes to fulfill all the design requirements (stability, resistance).

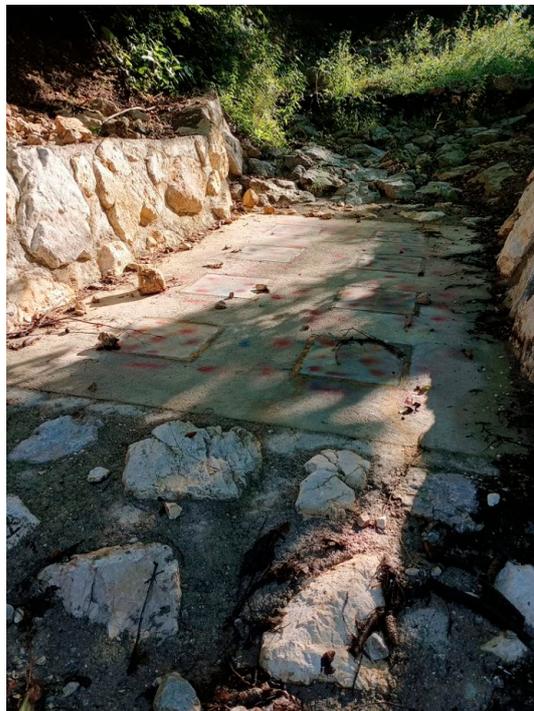
Figure 12. A field test site in the lower Brezovški graben for monitoring concrete abrasion—an upstream view.

- A field test site for concrete abrasion measurements due to sediment transport in torrential streams; in the bottom of the Brezovški graben a concrete flat ramp appr. 2.5×4.5 m was built in with an array of the total eight concrete square 5 cm thick plates (4×2 smaller concrete plates of the dimensions 50×50 cm prepared from four different concrete mixtures—two plates of each mixture) (Figure 12). One concrete mixture was a typical one used in torrent control works in Slovenia, and the other ones were prepared with additives, such as microsilica and steel fibers, to enhance their abrasion resistance. The plates are leveled in height with the ramp, not cast into the ramp but put in place so that they can be easily removed after the end of the field test. The ramp and the plates are regularly measured by terrestrial laser scanning to estimate abrasion depth on the plates due to overflowing sediments. Since flexible barriers were put in place in late 2022, concrete abrasion is rather limited and cannot be reported in this article yet. We expect that in situ measurements of concrete plate abrasion will correspond well with the standardized laboratory tests for underwater abrasion of concrete [34]. Positive experiences regarding concrete abrasion resistance of different concrete mixtures typically used for hydraulic structures were gathered in the past on the Lower Sava River in Slovenia [35].

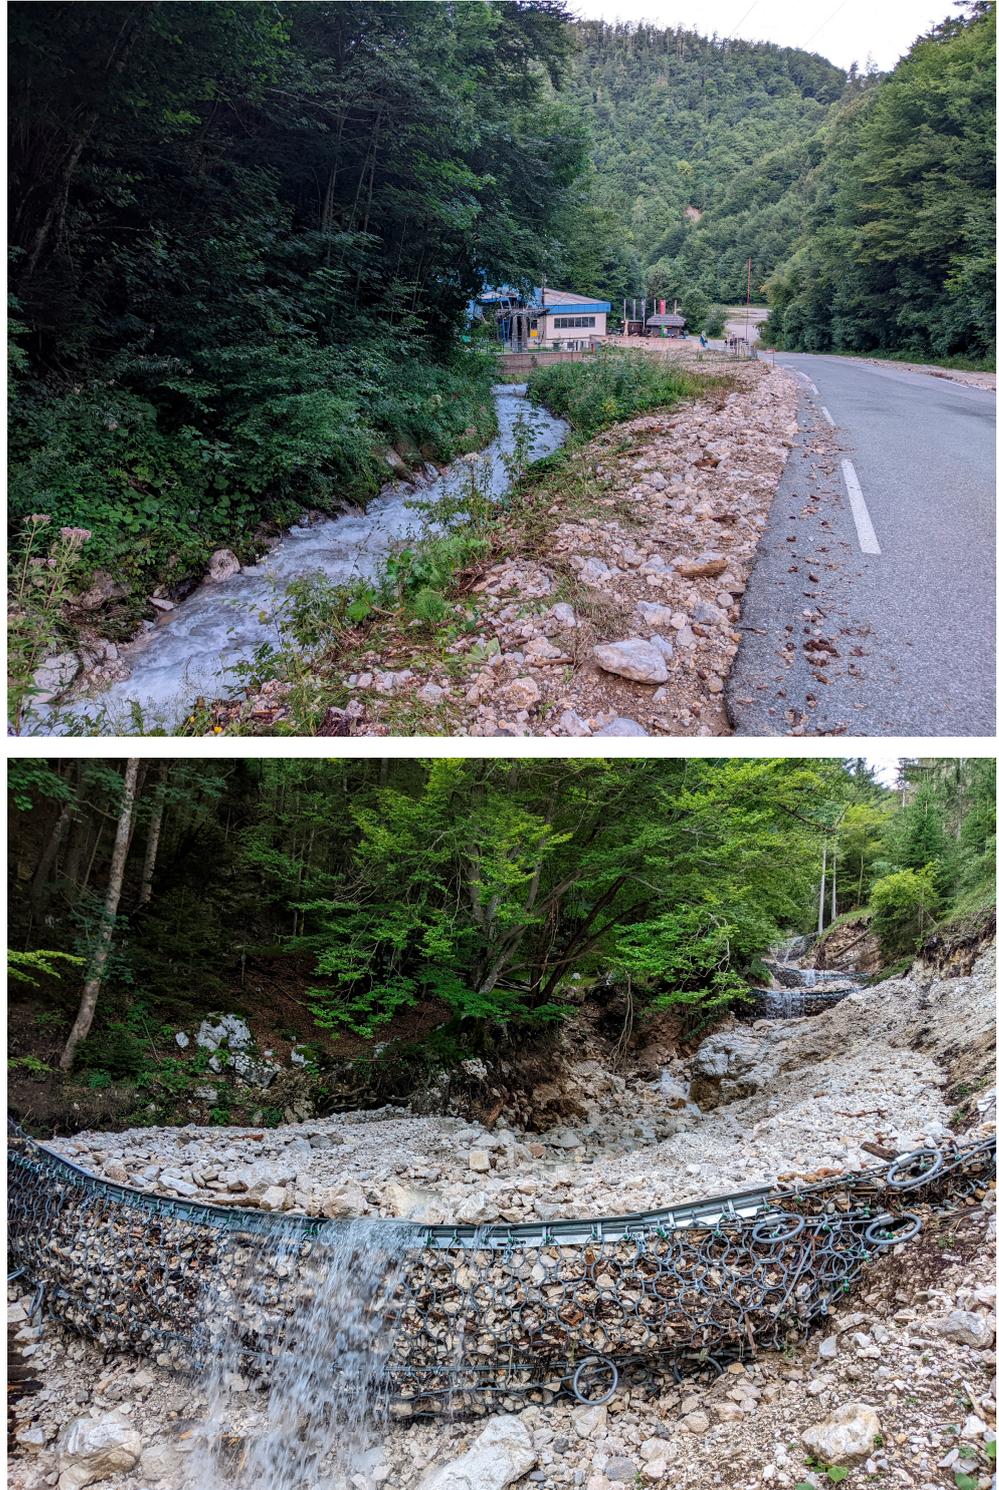
Figure 13. A situation in both torrents after the extreme August 2023 event.

On 3–4 August 2023, extreme rainfall caused intense erosion processes and mass movements, such as debris flows, slumps and landslide slips, and especially large and devastating floods in many parts of Slovenia [26,27]. The Krvavec meteorological station measured 30 mm in 30 min, 165 mm in 12 h and 196 mm of rainfall in 24 h, and rainfall erosivity for this event was over $1500 \text{ MJ} \times \text{mm} \times \text{ha}^{-1} \times \text{h}^{-1} \times \text{year}^{-1}$ —approximately 50% of the mean annual rainfall erosivity for this station and larger than during the previous extreme event (i.e., 2018). The return period of 12 h rainfall amount was estimated to be over 250 years. The 12 h rainfall intensity was also larger than the one associated with empirical rainfall threshold curves for the initiation of shallow landslides and debris flows—e.g., the one proposed by Caine in 1980 [36–38]. Hence, numerous smaller landslides, slumps and soil slips occurred in this area, and flexible net barriers were able to

retain the eroded material (Figure 13) and stabilize the channel bed without excessive channel incision. Consequently, the cabin car ski lift was not affected, as was the case during the May 2018 event, and no significant damage was caused in this part of the catchment (Figure 13). Based on the field geodetic survey using drones, it was estimated that around 19,000 m³ of material was eroded during the August 2023 event, and the majority of the debris material was trapped by the flexible net barriers.
